# Manhole Inspection Summary

Manhole # S02CC2013MH

**Location** Address: **6700 CROSS COUNTRY BLVD** Cross Street: **CLARKS LN**

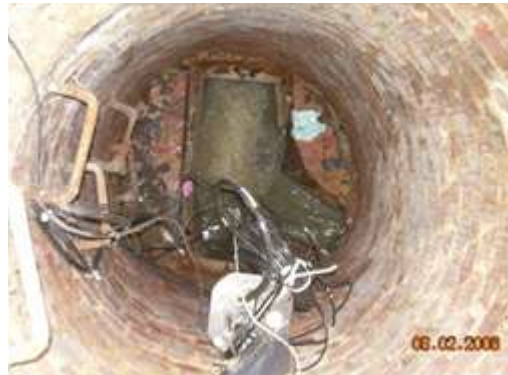
Top View

Adjustment, Corbel, and Barrel infiltration.  
Evidence of surcharge - Bench debris.  
Corroded steps.

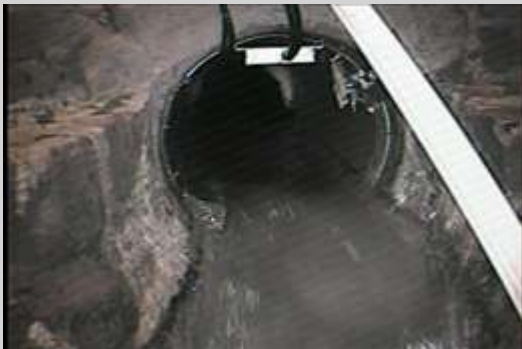
### 12 in. Circular Gravity Sewer Pipe In @ 4 O'Clock

Infiltration: **Evidence** Pipe Seal Cond: **Roots**

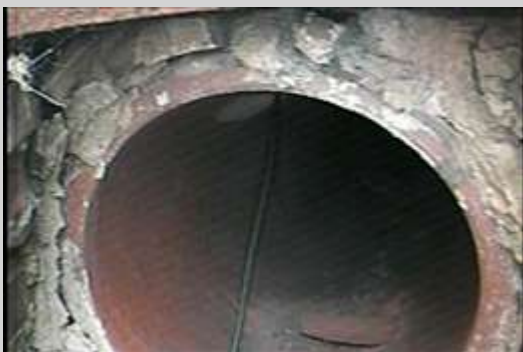
### 12 in. Circular Gravity Sewer

Infiltration: **Evidence** Pipe Seal Cond: **Broken**
